KITSUMKALUM FIRST NATION BRITISH COLUMBIA

Phase I Environmental Site Assessment

Report Number: 1314750024-001-R-Rev0

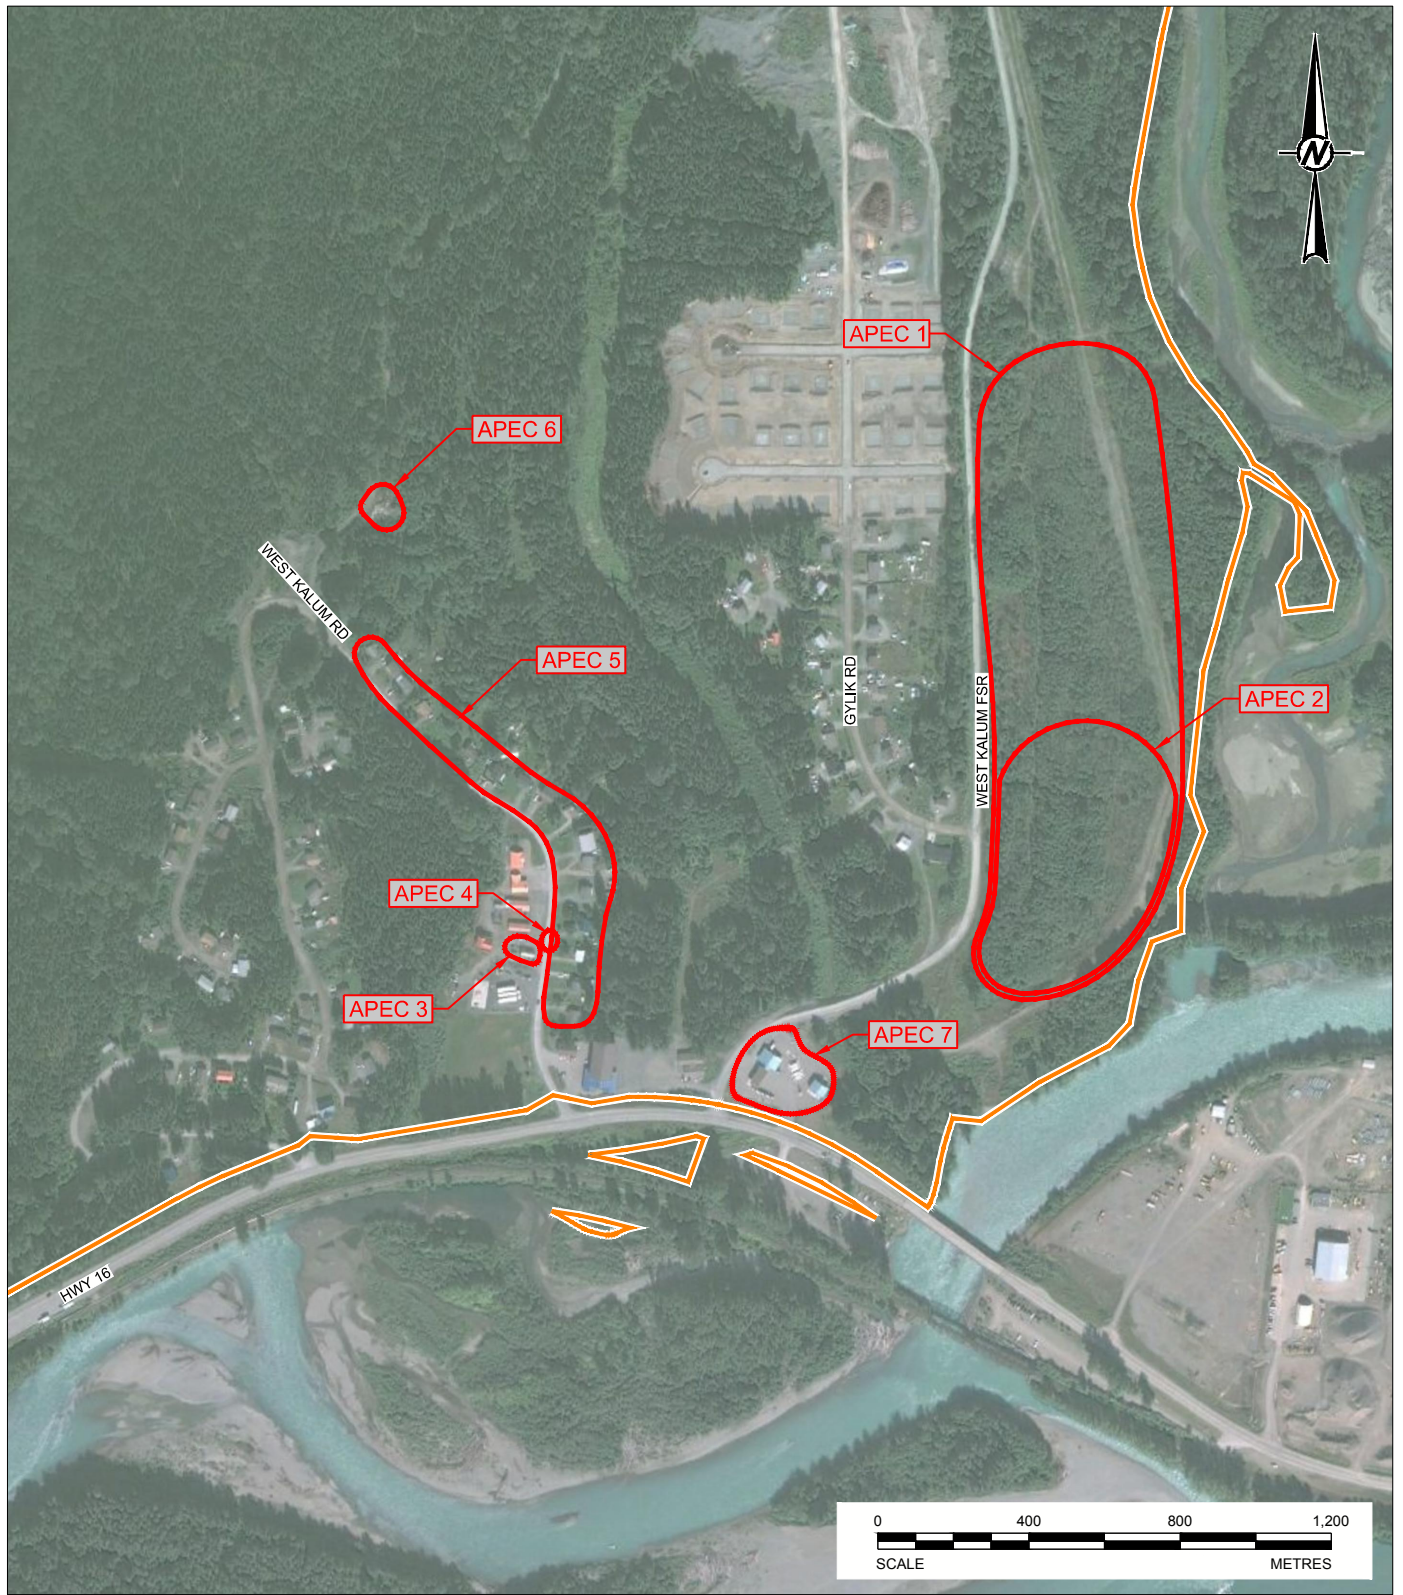
TITLE **KITSUMKALUM IR#1
 ON-SITE AREAS OF POTENTIAL
 ENVIRONMENTAL CONCERN**

Based on the results of the Phase I ESA, a total of seven on-site APECs from two Reserves (IR #1 and IR #3) and one off-site APEC were identified. A description of the APECs, PCOCs and recommended actions is provided in the table below.

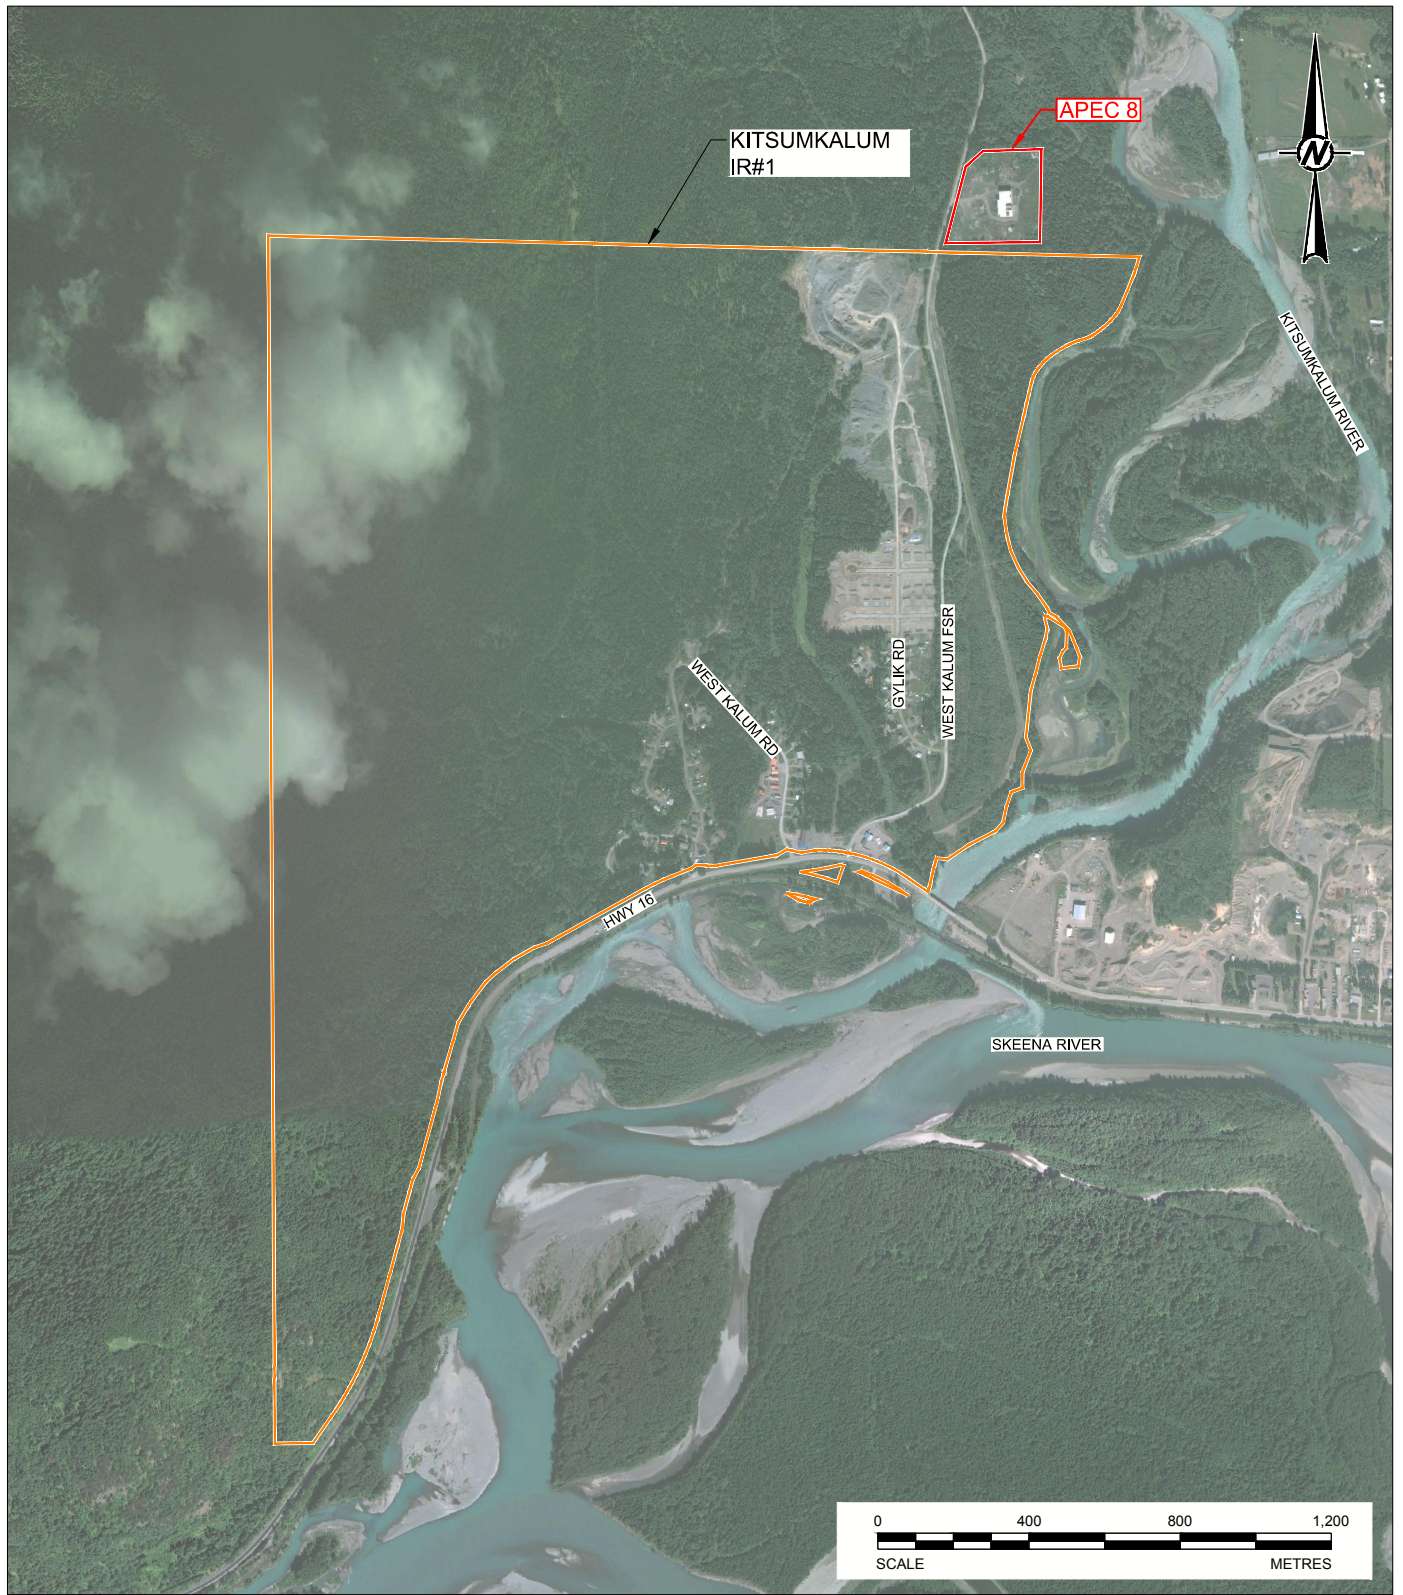
TITLE	OFF-SITE AREAS OF POTENTIAL ENVIRONMENTAL CONCERN
--------------	---

APEC 7 – Tempo Gas Station	X		Hydrocarbons, metals	Fuel storage and dispensing since late 1990s.	Complete a soil vapour survey to assess subsurface conditions in the fuel storage and dispensing areas. If contamination is encountered, complete additional investigation work to evaluate possible impacts to groundwater.	
APEC 8 – Offsite: Former Kalum Forest Products Mill Site	X		Hydrocarbons, metals, tanins, lignins	A total of 10 APECs were previously identified in 2010 at the former mill site located north of IR#1. Potential for migration of impacts from offsite APEC 8 to IR#1.	Soil and groundwater investigation along northern edge of IR#1 adjacent to former mill site. Assess soil and groundwater conditions and determine local direction of groundwater flow to assess possible impacts to IR#1 from off-site APEC.

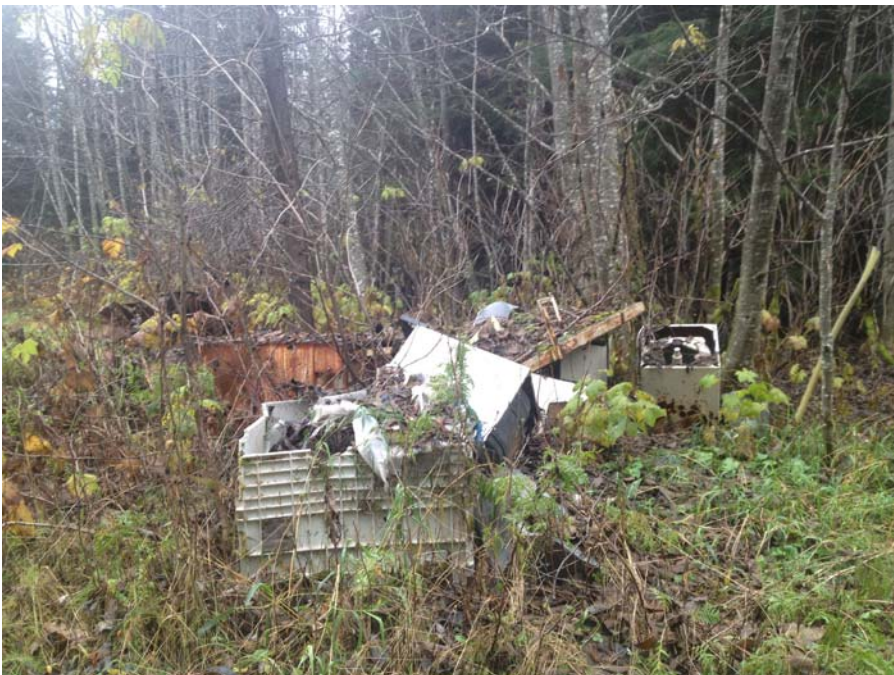
Figure 30: Dumpsite.

Site/Area	Classification of Risk		Contaminants of Potential Concern	Description of Contamination or Risk	Recommended Action	PMC Decision
	Contamination					
	Potential	Actual				
APEC 9 – Zymagord Dumpsite	X		Metals	Located on IR #3. Various wastes in the area, including abandoned vehicles and home appliances.	Complete test pit or drilling assessment in the area. If contamination is encountered, borehole drilling should be completed to determine its extent and groundwater contamination should be evaluated through installation and sampling from monitoring wells.
